Principles of Re-establishment Exercise 5

Original Survey Marks Missing but Occupation Existing

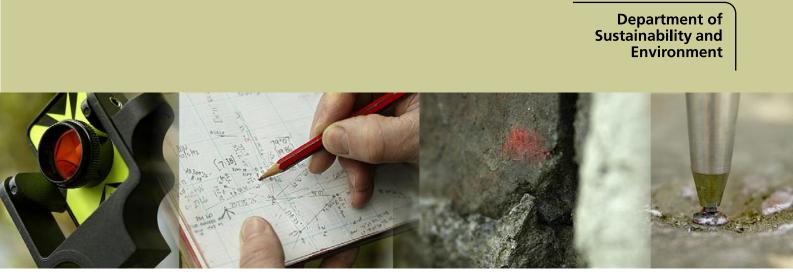
In 1951, the results of a Crown survey to define the boundary between Crown allotments 1 and 2 are shown on the first diagram above. A recently constructed fence is shown not to be coincident with the adopted boundary.

In a recent survey of the boundary it was found that the pegs placed in 1951 have been destroyed but the fence, which is more than 50-years-old, still exists.

In this case, the relationship between the adopted boundary and occupation remains as it was in the 1951 survey. The fence is not the Crown boundary.
